**Architectural Impact Assessment for the remnant excavations
and structures on Erf 29 of 3 of Leeuwbosch 1275,
Brookwood Manor Farm, Fort Nottingham**

August 2010
Prepared for: Mr D Robinson
Brookwood Manor Farm
Fort Nottingham

Architectural Impact Assessment for the remnant excavations and structures on erf 29 of 3 of Leeuwbosch 1275, Brookwood Manor Farm, Fort Nottingham

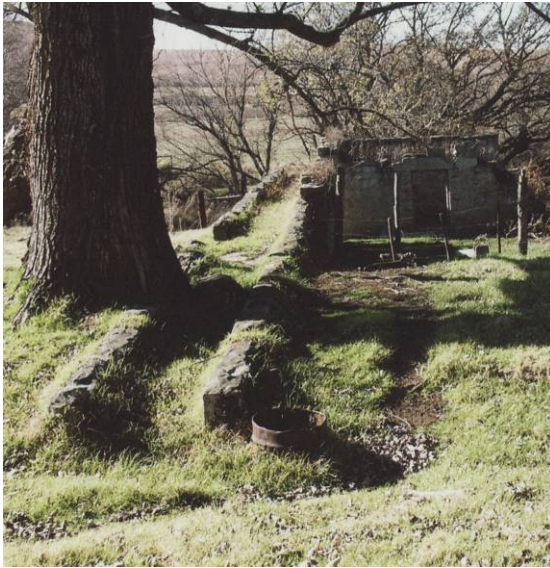
Fig 19: Mill race from Staples (2006)

The mill race is constructed out of semi- dressed fieldstone laid in lime mortar beds, and connects the mill stream and the mill race. Fig 19 shows the mill race from Staples' 2006 publication. Water access to the mill race would have been controlled by a penstock, and the extra water channelled back to the river. At the end of the mill race would have been a wooden launder or flume, which would have carried the water over the wheel to drive it. No evidence of this flume exists.

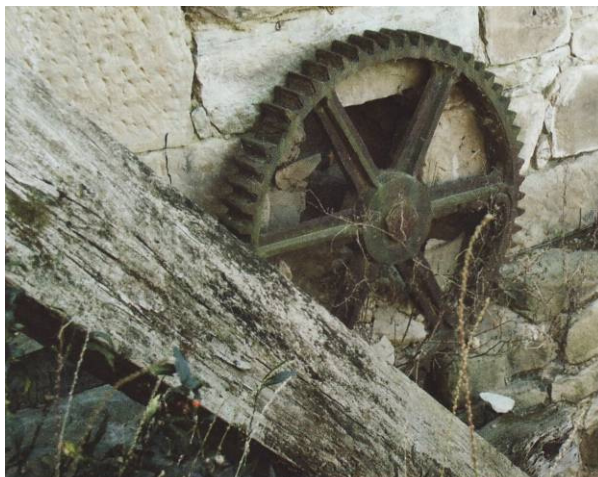
Fig 25: Kintail Steel overshoot wheel (Staples 2006)

There is no evidence of the steel overshot wheel, or millstones. Internally there were two floors, with a suspended timber floor which has been long destroyed or removed. The walls are of fieldstone which is roughly coursed, and besides major holes in them, structural damage is in evidence with collapsing lintols. The mill has no roof. To the north- west is a series of terraces, adjoining the mill race, where burnt timber posts indicate a rough extension.
